County of Cumberland Mid-County Park Master Plan

March 2024

Section 1: Introduction & Existing Conditions

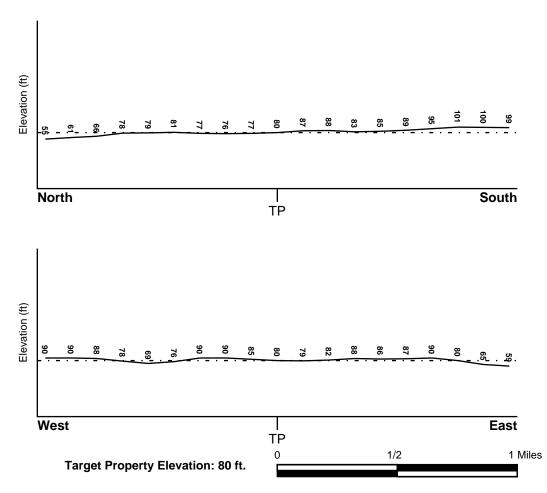
SURROUNDING TOPOGRAPHY: ELEVATION PROFILES

Source: Topography has been determined from the USGS 7.5' Digital Elevation Model and should be evaluated on a relative (not an absolute) basis. Relative elevation information between sites of close proximity should be field verified.

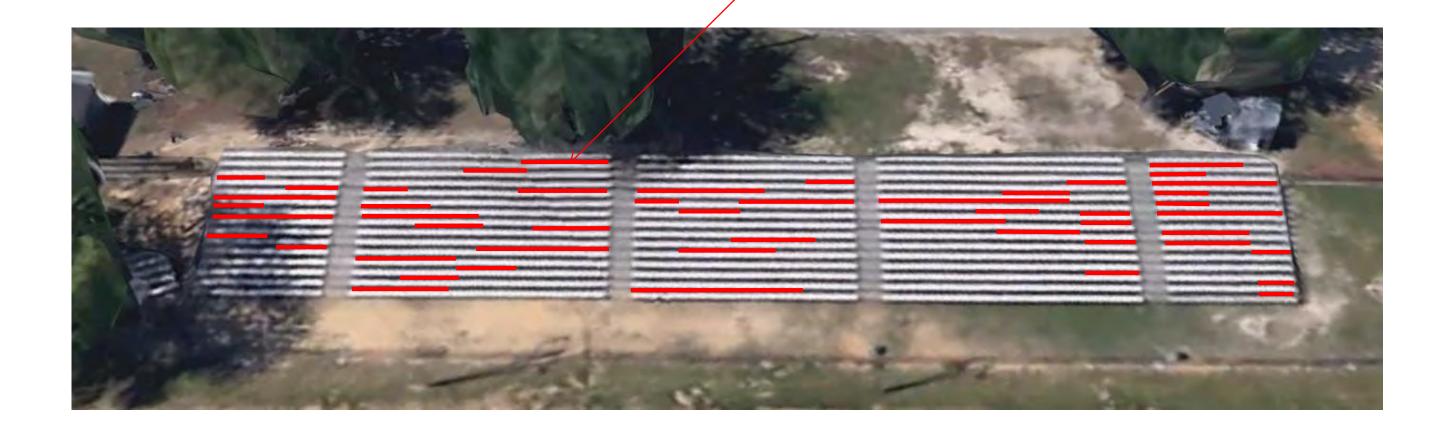
DENOTES APPROXIMATE EXTENT OF ROTTED / DETERIORATED WALKWAY WOOD PLANKS THAT WERE NOTED IN THE FIELD AS REQUIRING REPLACEMENT
